**FALLUJA WASTE WATER  
TREATMENT SYSTEM  
FALLUJA, IRAQ**

**SIGIR PA-08-144  
SIGIR PA-08-145  
SIGIR PA-08-146  
SIGIR PA-08-147  
SIGIR PA-08-148**

**OCTOBER 27, 2008**

## Falluja Waste Water Treatment System

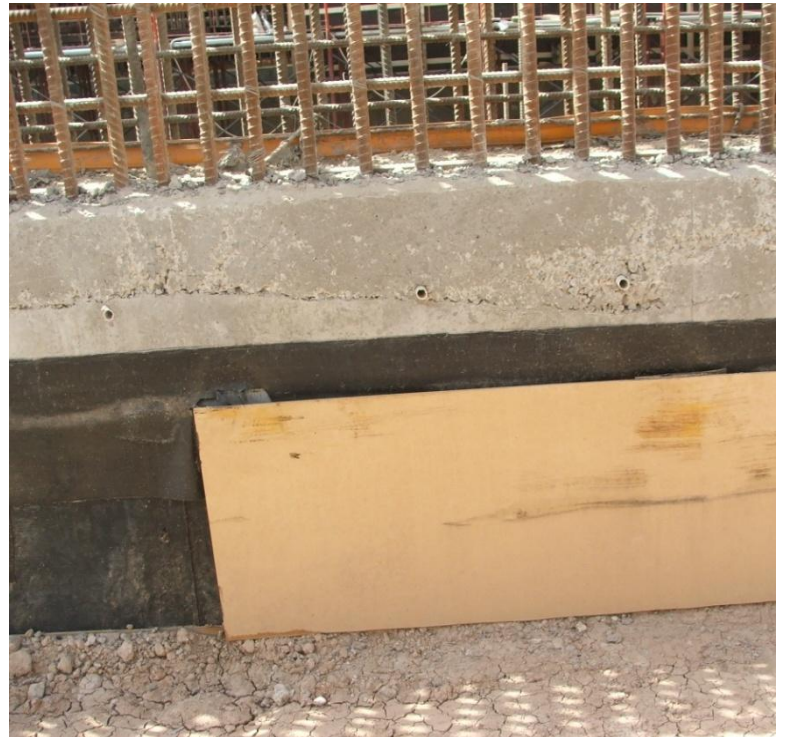
**Site Photo 21. Inadequate concrete area (behind cover)**

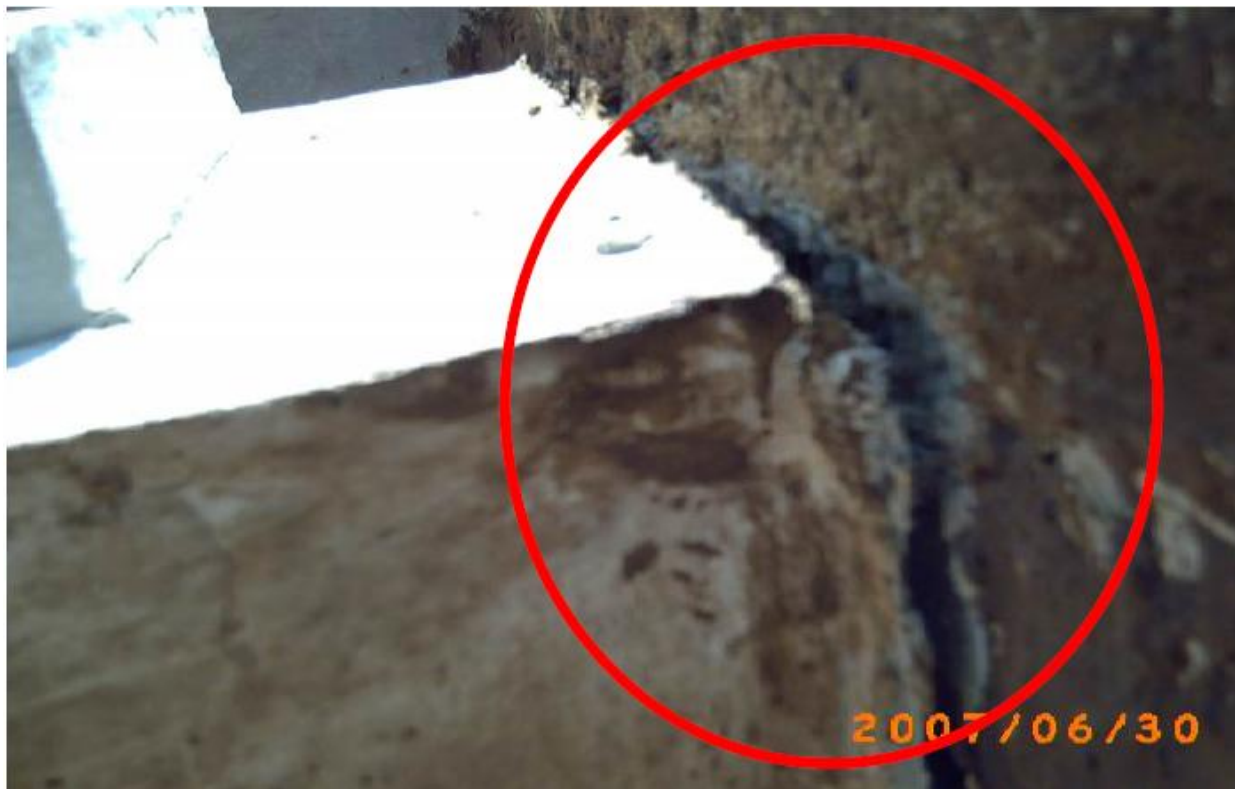
**Site Photo 22. Deficiency identified in daily QA report by field engineers  
(Courtesy of the USACE)**
